CASE STUDY

Waterford water treatment plants/Waterford, CT

Connecticut Project Takes Steps To Ensure Worker Safety

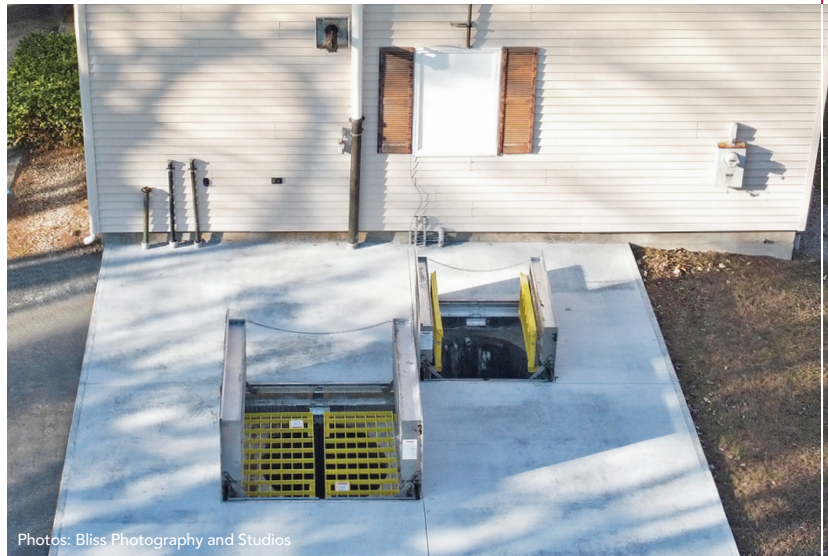
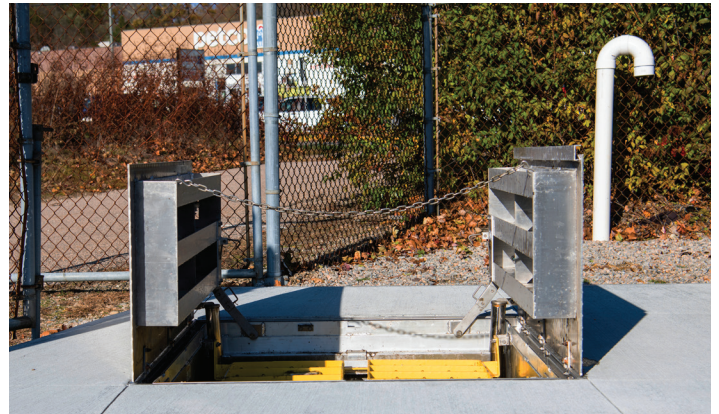
The BILCO doors are constructed with a channel frame for use in exterior applications where there is a concern of water or other liquids entering the access opening. The doors feature aluminum construction and type 316 stainless steel hardware. They also include engineered lift assistance for one-hand operation.

Fall protection grating is an important feature in the Waterford project. The grating system allows workers to safely inspect pumps and monitor underground areas. It also meets OSHA requirements for fall protection for access doors. Recently redesigned, the fall grating system includes a powder coat paint finish and a hinge design that allows the grating to open to the full 90-degree position.
