CASE STUDY

Hazardous Material Storage Building/Cross Junction, Virginia

Hybrid Hatch Solution Solves Dilemma With Corrosion

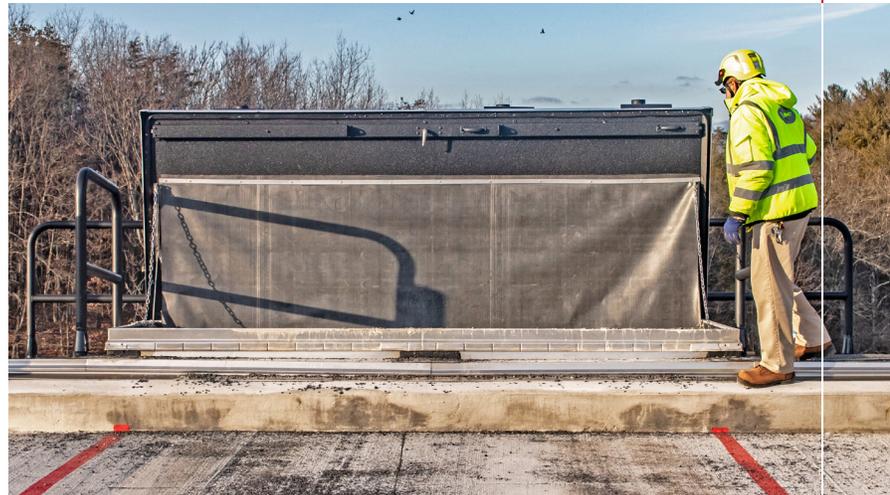
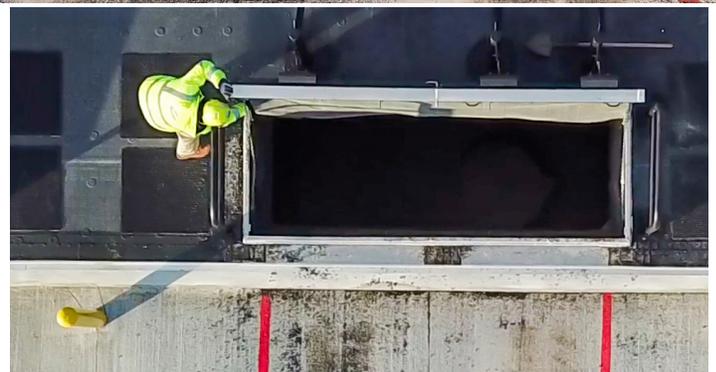
They specified three aluminum models, each 3-feet, 11-inches wide and 11-feet long. The custom-made hatches include Type 316L stainless steel hardware, which is the most corrosion-resistant type of stainless steel.

As another layer of protection, the roof hatches include a liner, which is similar to the lining on truck beds. Installed by Rhino Linings of Winchester, Va., the spray-on material protects against corrosion

while also providing abrasion, impact, and chemical resistance. The aluminum hatches with the liner were more cost-efficient than stainless steel roof hatches.

One other critical design component are steel bumpers that support the roof hatch during loading operations. "The additional force applied to the roof hatch covers during the salt loading is then directly transferred to the steel bumpers to protect the structural integrity of the roof hatches," Stein said.
